**DEPARTMENT OF TRANSPORTATION**

Contract #: 04-0120F4Cty: SF/ALA Rte: 80 PM: 13.2/13.9File #: 1.28**WELDING INSPECTION REPORT****Resident Engineer:**Siegenthaler, Peter**Address:** 333 Burma Road**City:** Oakland, CA 94607**Report No:** WIR-023230**Date Inspected:** 02-May-2011**Project Name:** SAS Superstructure**OSM Arrival Time:** 700**Prime Contractor:** American Bridge/Fluor Enterprises, a JV**OSM Departure Time:** 1530**Contractor:** American Bridge/Fluor Enterprises, a JV**Location:** Job Site**CWI Name:** N/A**CWI Present:** Yes No**Inspected CWI report:** Yes No N/A**Rod Oven in Use:** Yes No N/A**Electrode to specification:** Yes No N/A**Weld Procedures Followed:** Yes No N/A**Qualified Welders:** Yes No N/A**Verified Joint Fit-up:** Yes No N/A**Approved Drawings:** Yes No N/A**Approved WPS:** Yes No N/A**Delayed / Cancelled:** Yes No N/A**Bridge No:** 34-0006**Component:** Tower**Summary of Items Observed:**

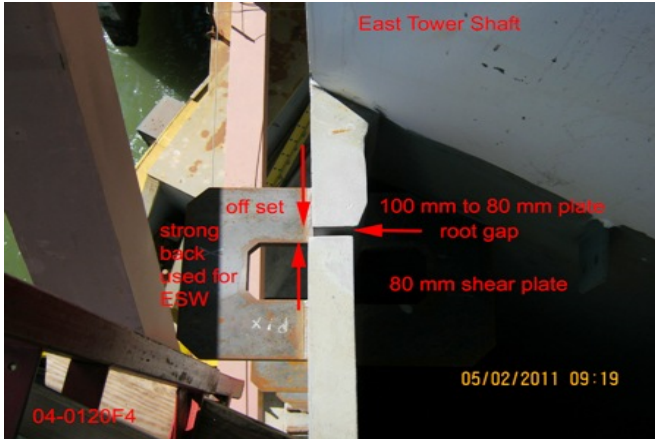
Measurements were taken at the following elevations: 3-meter, 5-meter, 9-meter, 11-meter and 13-meter. By the end of the shift this measurements had been taken at all areas accessible, approximately 196 of the proposed 200 measurement locations had been accessed and measurements taken; see photo below of weld joint #16 (East Shear plate, South corner) from the 13 meter elevation.
